Study on Lightning Damage Mechanism of Wind Power Generators

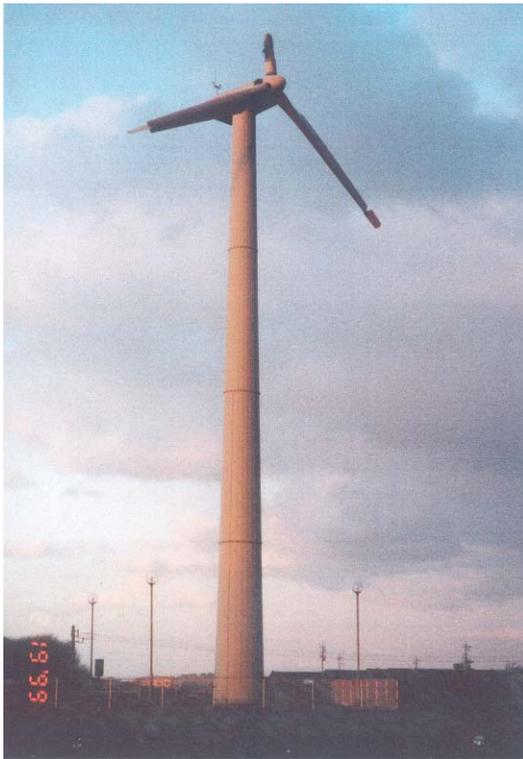
Fig.1 Damage of wind turbine blade due to lightning

In recent years, the utilization of wind power is rapidly increasing in electric power supply. The increasing number and height of installed turbines have resulted in an increase of lightning damages. Especially lightning damage to wind turbine blades is quite serious since the cost of replacements is remarkably high and a long repair time is necessary. Hence, lightning protection measures for wind turbines are becoming increasingly important as their use is rapidly increasing.

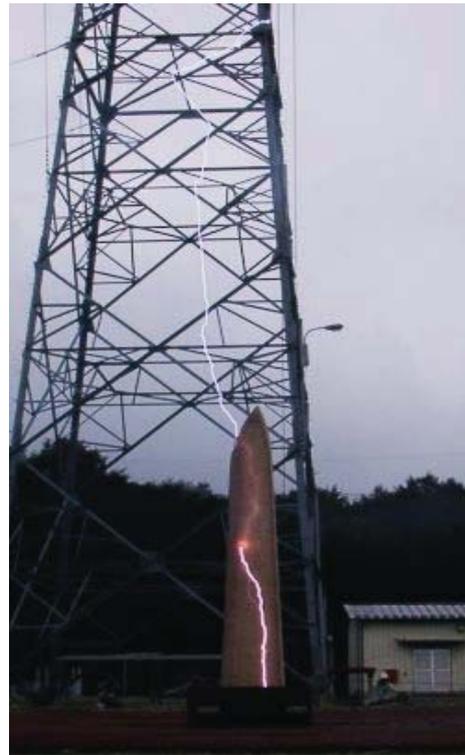
Fig.2 Lightning discharge on wind turbine blade model

Using a large high voltage generator at Shiobara Testing Yard, lightning attachment characteristics to wind turbine blades were clarified experimentally.

- (1) Lightning can discharge to blades made of insulated material only. In the case that the insulation strength of material was not enough, discharge stroke penetrated the material and intruded inside.
- (2) Insulation strength of blade materials decreases if the surface of them is polluted by the adhesion of a salt deposit. At seaside or offshore locations, the effect of pollution should be taken into consideration for non-conductive blades.
