# Stress Corrosion Cracking of Stainless Steel Canister of Concrete Cask

Central Research Institute for  
Electric Power Industry

J. Tani, K. Shirai, M. Wataru and T. Saegusa

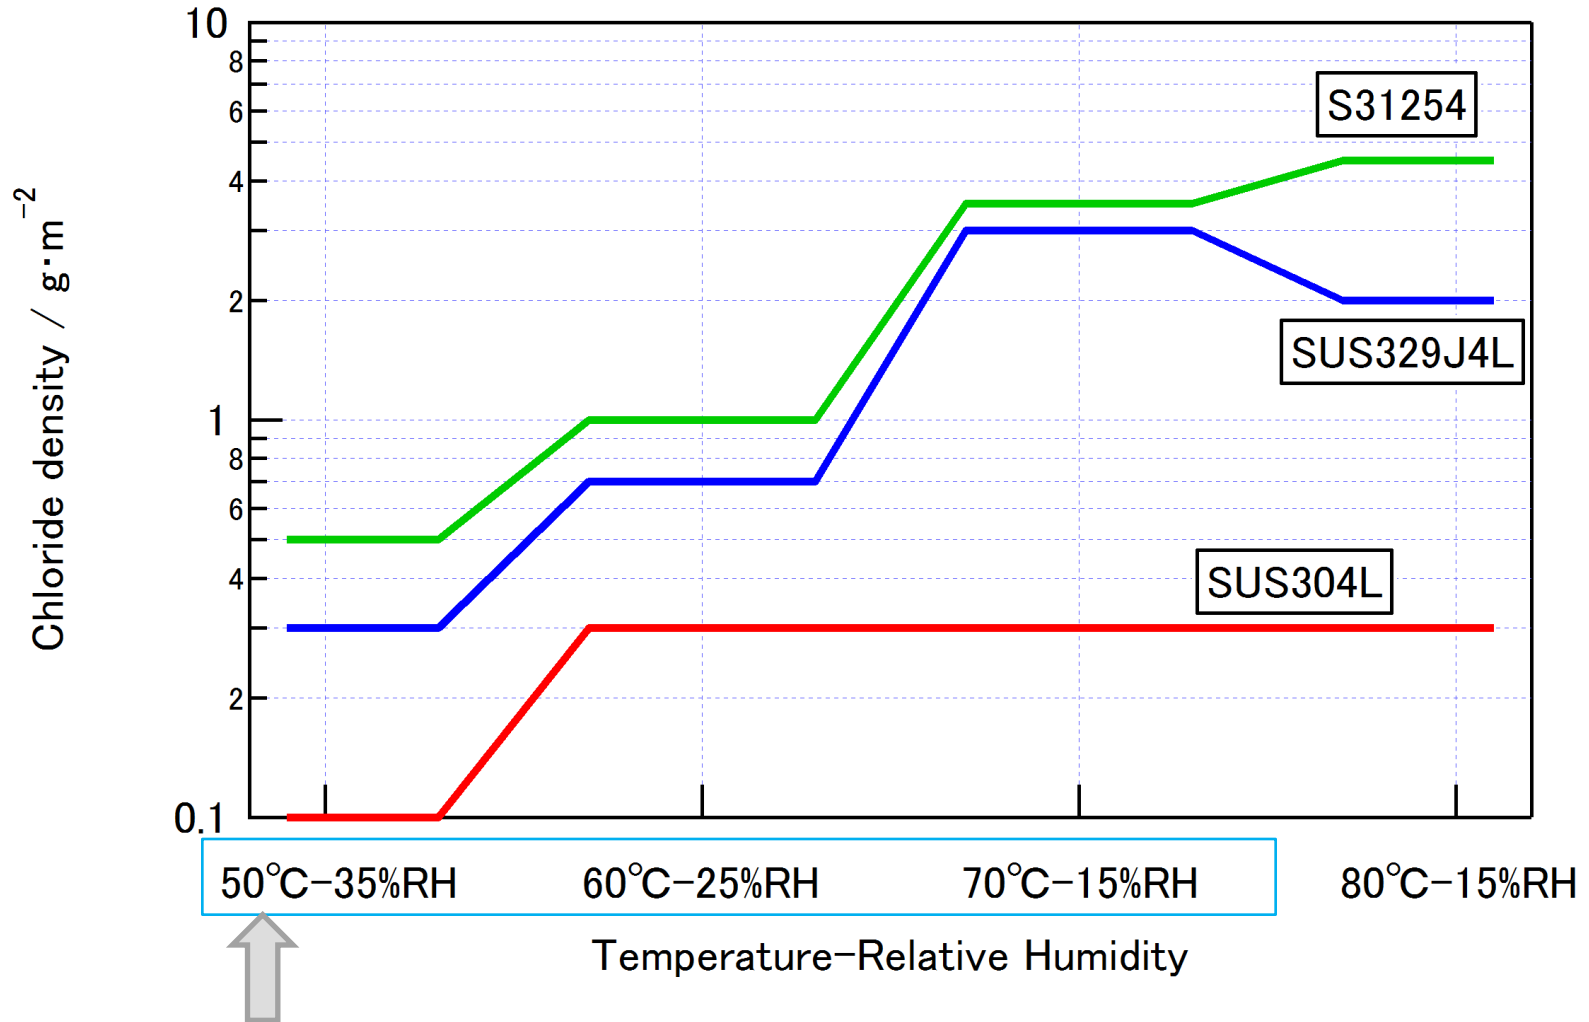
# Chloride density for Rusting

Satisfy absolute humidity of 30g/m<sup>3</sup>

Material	Rusting	Cracking	PRE*
S30403	0.1	0.3	18.3
S31260	0.3	1	37.8
S31254	0.5	10**	43.3

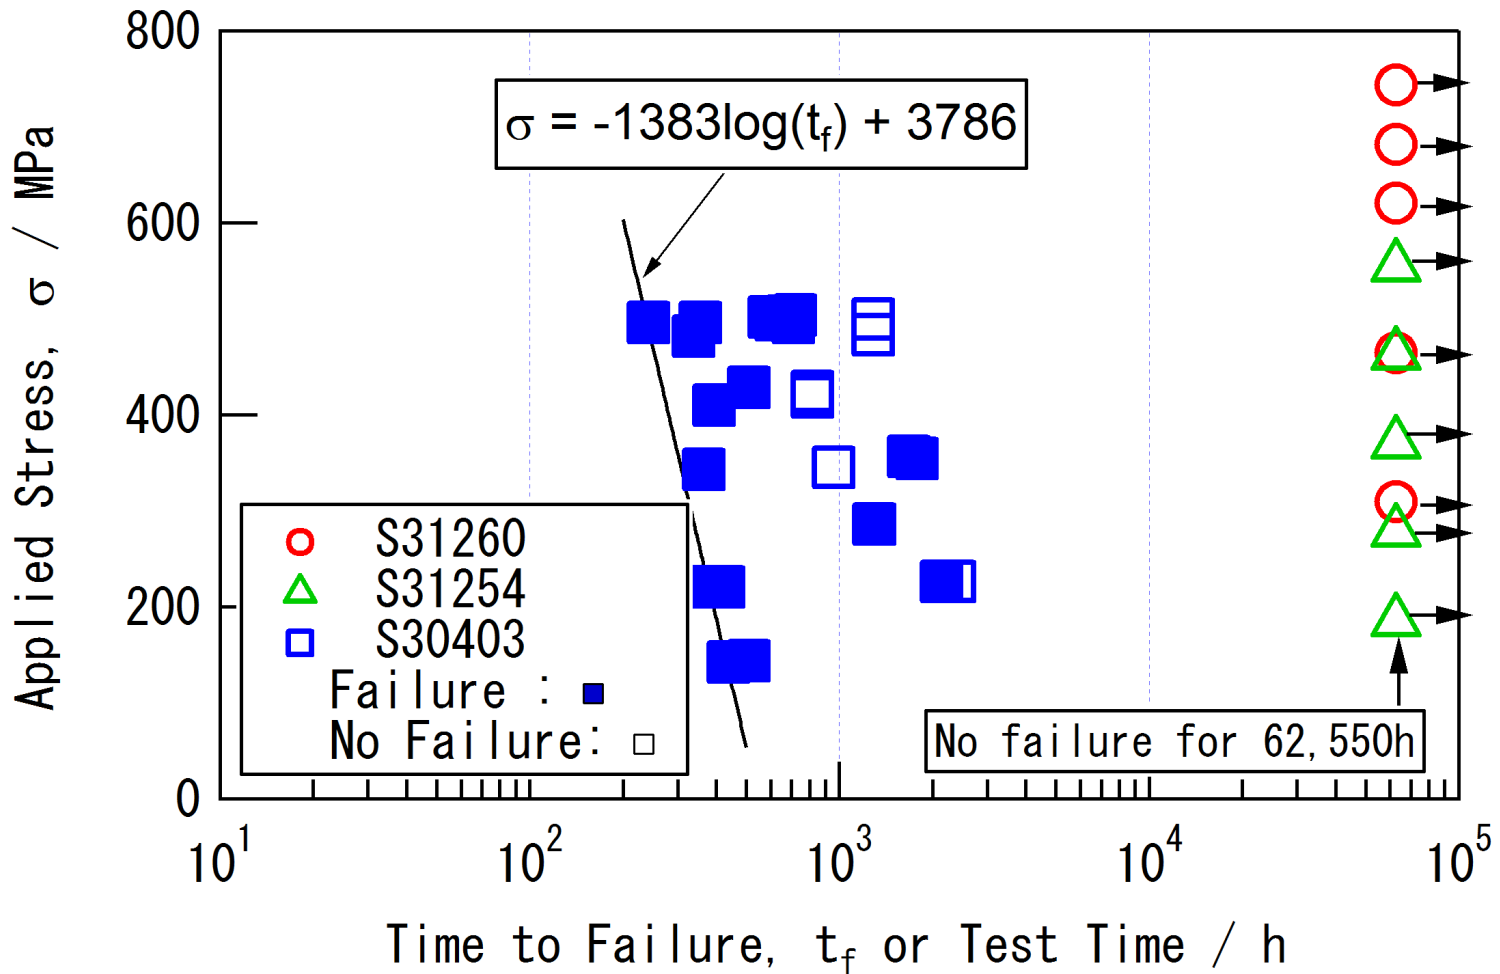
# SCC resistant material

Test condition: 80C, 35%RH, 10g/m<sup>2</sup> as Cl(sea salt)

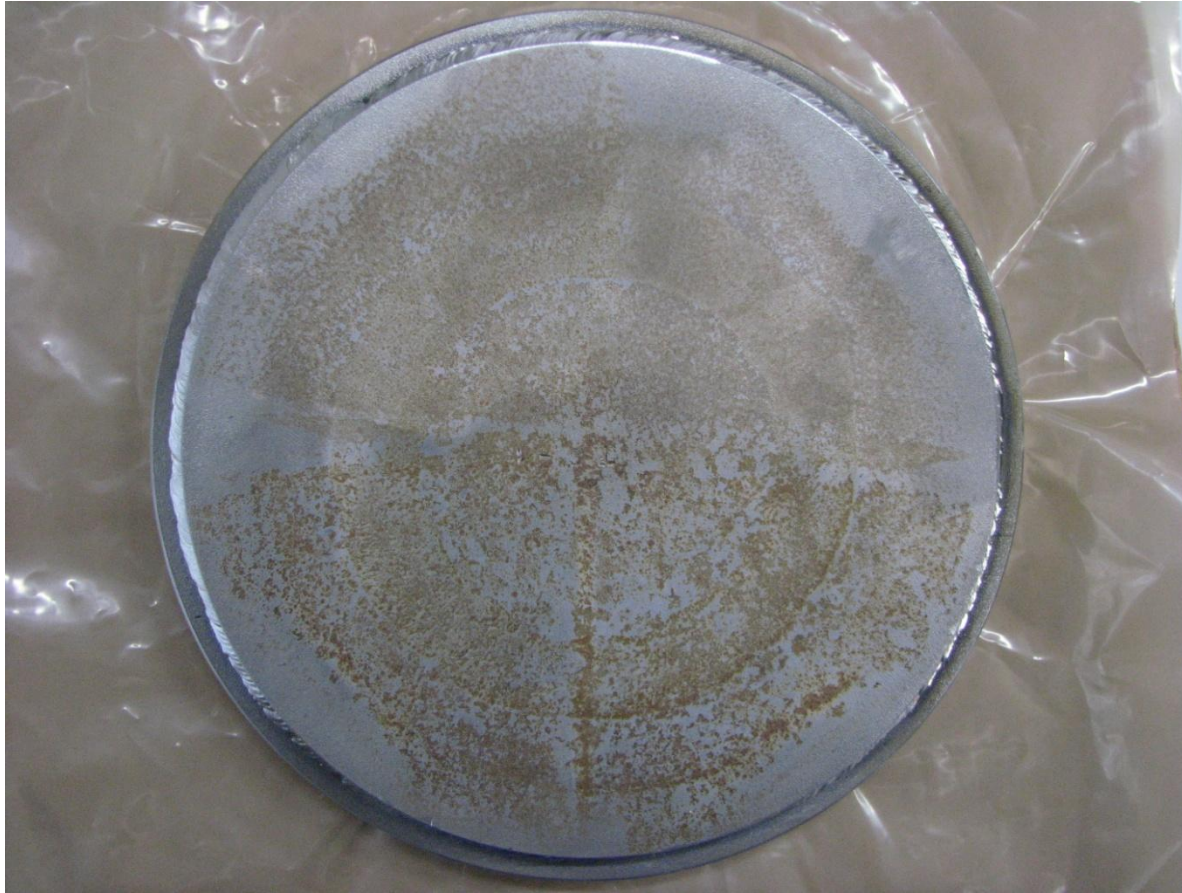
# Experiment for residual stress relaxation

Weld (TIG, Laser)

(Unit:  $\text{g/m}^2$  as Cl)

After 2000h in 50C,  
35%RH

This specimen has no stress relaxation.
